# Failures of Screws and Their Preventive Methods

Emeritus Prof. of Saga University,  
Shin-ichi Nishida

## —Environmental failure of bolts, (the first half), 3rd report—

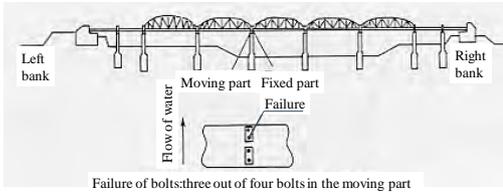
Fig.3.1 Condition of failure (see Fig.3.2)

During his round of inspection, an inspector found broken bolts scattered on the dry ground on the river. The bolts were assumed to be the ones used in a water-tube bridge. On closer inspection, it was found that they were anchor bolts used in the moving part of a bridge pier. The condition of failure is shown in Fig.3.1 Three out of four bolts were broken and their nuts were scattered on the dry ground (ref. Fig.3.2). The bolts had been in service for 14 years and 9 months before their failure was detected.

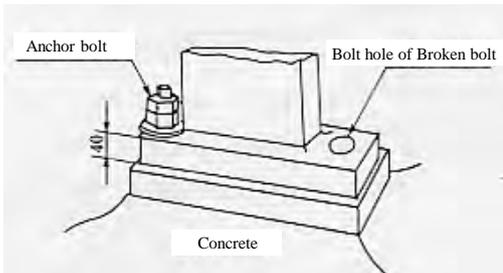
Fig.3.2 Anchor bolt set in place

The bolt is made of a steel equivalent to SS400. No trace of macroscopic plastic deformation is observed on the fracture surface. The diameter in the direction which is supposed to be the direction of crack propagation is shorter by about 3 mm than the diameter in a direction at right angles to the above direction. The position of failure is the bottom end of the fastened part but not the end section of the nut where the maximum stress usually develops. A striation-like pattern and fissures are seen on the fracture surface, although not clearly. On the basis of these results, the cause of failure of the bolt is estimated to be fatigue failure caused by the cyclic shear stress induced with the repeated application of the shear force which had been produced by the expansion and contraction of the bridge pier during about 15 years in service accompanying with tensile stress. Moreover, the corrosive atmosphere is also responsible. Accordingly, the diameter on the side where the shear force was applied is smaller by about 3 mm.

As a countermeasure, the anchor bolt hole should be enlarged in consideration of the thermal expansion of the bridge pier, or the anchor bolt should be set nearly at the center of the bolt hole so that it is not affected by the thermal expansion of the bridge pier.

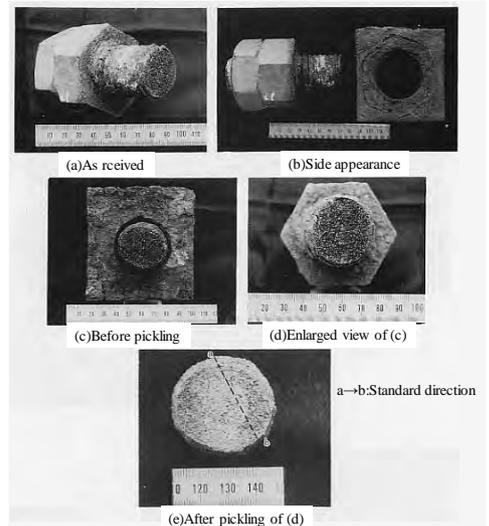
Figure 3.4 shows the appearance of the broken bolt. The failure initiated at a point about 47mm from the end section of the nut. This distance is exactly equal to the sum (46mm) of the thickness of the fastened part (40mm) and the thickness of the washer (6mm). The broken bolt was fairly corroded and the fracture surface was not clear because of corrosive rust. However, careful observation revealed a faint pattern extending in the a—b direction which looks like a crack propagation pattern [ref. Fig.3.4(e)]. This direction is considered as the standard direction in Fig.3.4. The diameter in the standard direction is shorter by about 3mm than that in a direction at right angles to the standard direction.

Fig.3.4 Outer appearance of broken bolt

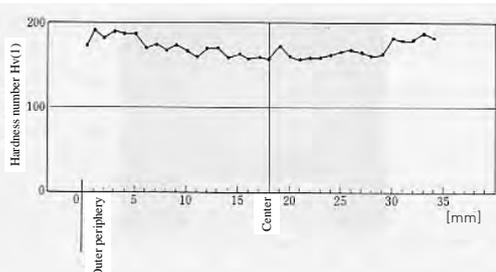
Fig.3.6 Hardness distribution

The chemical composition and optical micrograph of the broken bolt are shown in Table 3.1 and Fig.3.5, respectively. The hardness distribution in the bolt is shown in Fig.3.6. On the basis of these

data, the steel grade of the steel is considered to be equivalent to JIS, SS400 (a representative mild steel). The structure is the typical ferrite-pearlite structure observed in low-carbon steels.

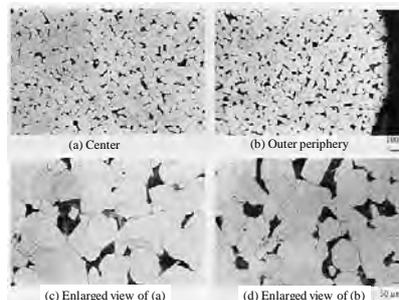
Fig.3.5 Microstructure of transverse section

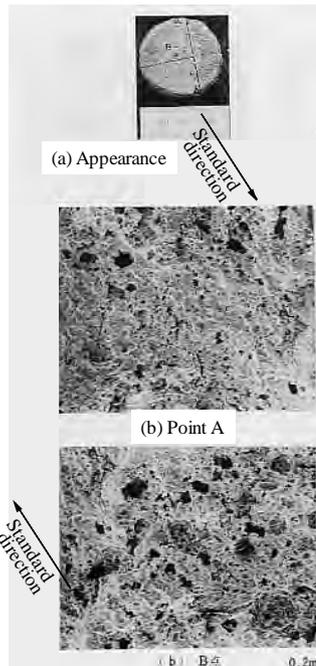
**Fig.3.7** Result of observation of fracture surface by SEM

The results of observation of the fracture surface are shown in Figs.3.7 and 3.8. As the bolt was exposed to a corrosive environment for a long period of time, an infinite number of corrosion pits is observed. It seems that changes were caused in the fracture surface due to the formation of a rust layer. Although not clearly seen, there is a striation-like pattern [see Fig.3.8(d)], and fissures are frequently observed in the fatigue fracture surface [see Fig.3.8(a)].

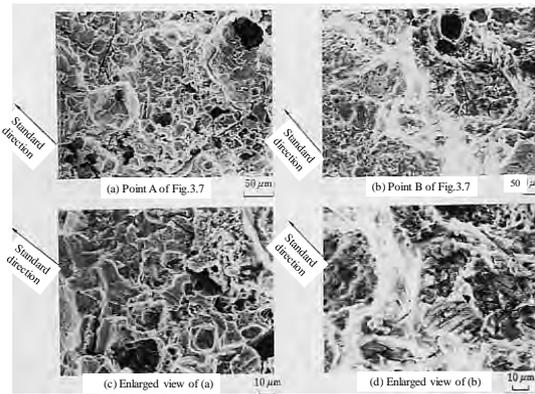
**Fig.3.8** Results of observation of fracture surface by SEM

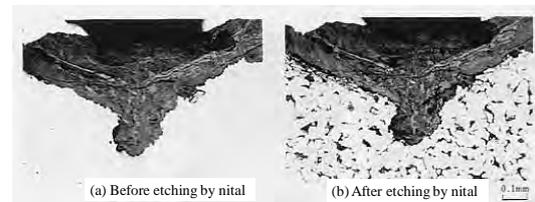
**Fig.3.9** An example of corrosion pit at the root of thread

An example of the corrosion pits at the thread root is shown in Fig.3.9. Figure 3.9(a) is the structure before etching and (b) shows after etching with nital. The depth of corrosion pits at the thread root is about 0.2mm. In addition, the width of the pits is about also 0.2mm.

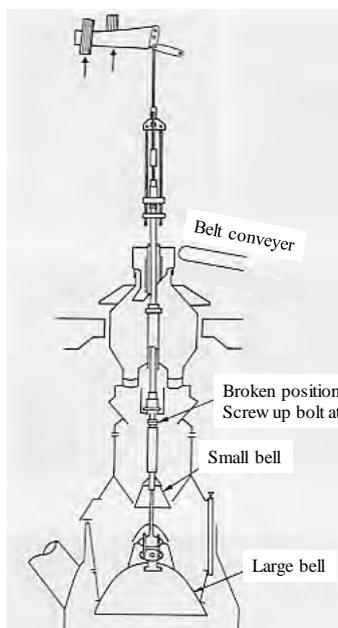
**Fig.3.10** Schematic drawing of blast-furnace top position of failure in the bolt

All 20 fastening bolts for the small bell rod flange installed at the top of a blast-furnace broke after 6 months of service. Bolt details: steel grade, SCM435 (QT steel), M42×190 mm in length, thread length, 87 mm, stress applied to the bolt, repeated stress amplitude  $\sigma_a=2.9 \text{ kgf/mm}^2$ , mean stress  $\sigma_m=10.4 \text{ kgf/mm}^2$ . In addition, the bending stress was also applied (see Fig.3.10).

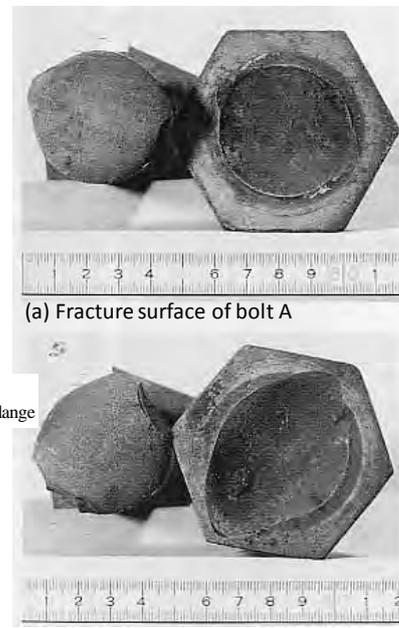
**Fig.3.11** Outer appearance of fracture surface of bolt

Out of 20 bolts, 18 bolts were broken under the head (R=0.7 mm) and two bolts at the end section of the nut (although the number of the broken bolts that could be collected was 15). The surface of the broken bolts was fairly corroded. In some bolts, axial bending and cracks at the thread root were detected (see Fig.3.11).

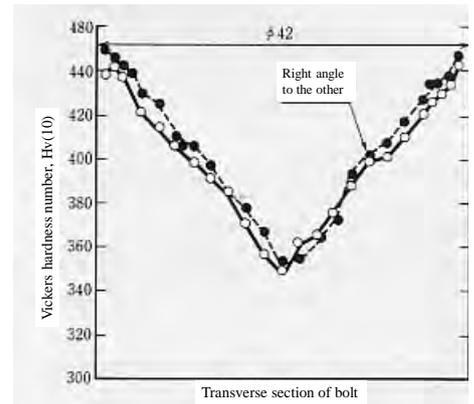
composition satisfies the JIS standard. The hardness distribution is shown in Fig.3.11. As there is a difference of 25% in hardness in the transverse section of the bolt, it is considered that the tempering of the bolt was insufficient, causing embrittlement of the surface.

**Fig.3.12 Hardness distribution in transverse section of bolt**

- (1) An increase in radius under the head (R=0.7→5.0mm for M42 thread).
- (2) Equalization of axial tension in the bolt to be an appropriate value by controlling the tightening torque.
- (3) A decrease in surface hardness by tempering at 550—650℃, and rust-preventive treatment.

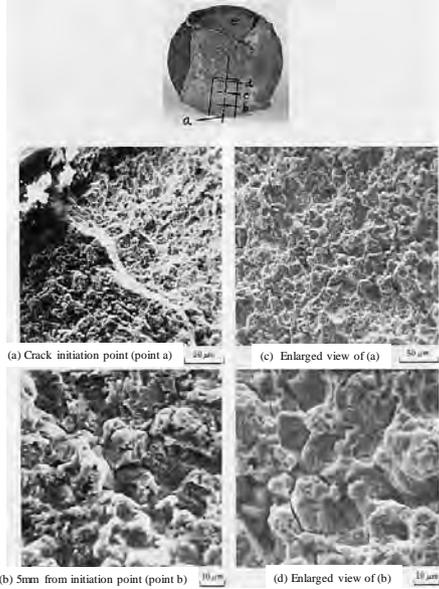
The results of observation are shown in Fig.3.11 and Figs 3.13 and 3.14. At the failure initiation point in the fracture surface, transgranular failure and intergranular failure coexist, with the former type predominating. The transgranular fracture surface resembles the fatigue surface of high strength steel but no striation is observed in it.

At a point 5-10 mm from the failure initiation point, the transgranular failure and intergranular failure coexist but the proportion of intergranular failure is higher (see Figs 3.13 and 3.14). Dimple and river patterns coexist in the final fracture surface.

**Fig.3.13 Results of observation by SEM of fracture surface of bolt A**

On the basis of the results described above, it is considered that fatigue cracks were caused by the stress concentration under the head of the bolt and their propagation was accelerated by the corrosive environment, finally resulting in failure.

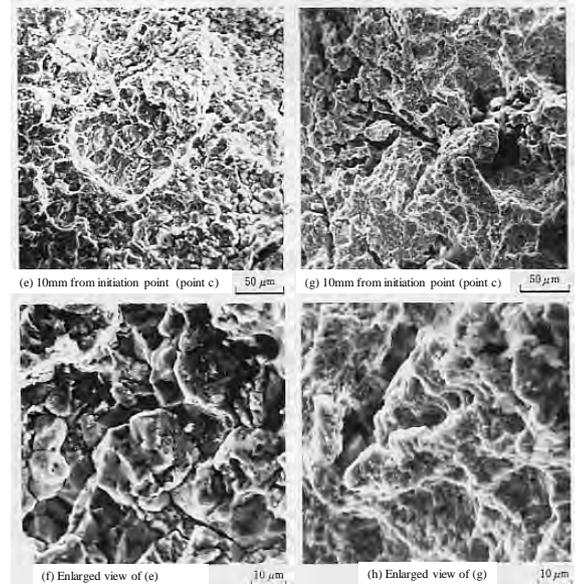
**Fig.3.14 Results of observation by SEM of fracture surface of bolt A**

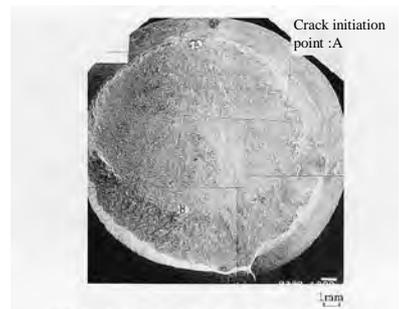
Figure 3.17 shows a fracture surface by delayed fracture of bolt. Though the record of this bolt in service is not clear at present, this is a representative delayed fracture of bolt. As the fringe part is external thread, the fracture is initiated from the end section of nut. The point A in Fig.3.17 is crack initiation one, propagate into the point B and to be a final fracture. The crack initiation point in this case is about 0.5mm inside from the bottom of thread. Figure 3.18 shows the enlarged view of point A in Fig.3.17. As shown in this figure, the hollows in the left and right-hand sides of the crack initiation point A is corrosion pits and these are generated in corrosive atmosphere. The enlarged view of (a) in Fig.3.18 is shown in (b). There intergranular fracture surface is observed in the crack initiation point. In addition, the transient area to final fracture is point B as shown in Fig.3.19. Though almost all area is occupied with transgranular fracture, the intergranular fracture also remains a little in this surface. The intergranular fracture resembles to half-melted candy, this is also called as “candy block”. The delayed fracture as predicted the above can be understood by the model shown in Fig.3.16.

Fig.3.17 Delayed fracture of high tension bolt ( $\sigma_B=1,100MPa$ )

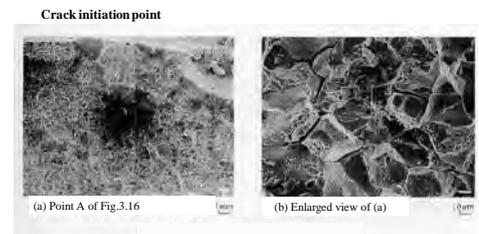
Fig.3.18 Delayed fracture of high tension bolt (enlarged view of point A in Fig.3.16)

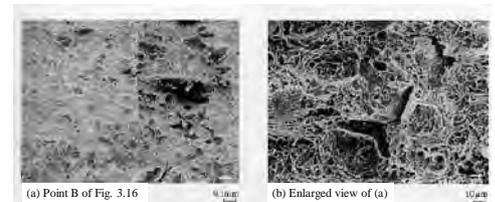
Fig.3.19 Delayed fracture of high tension bolt (enlarged view of B point in Fig.3.16)

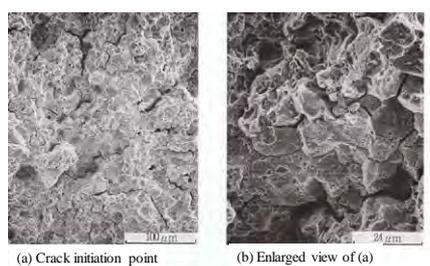
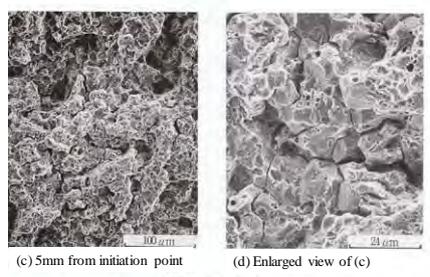
Figure 3.20 shows another example by delayed fracture of high tension bolt. This bolt is M22 in nominal diameter and contains boron (B) with tensile strength of 1,250MPa. In addition, the bolt has been used in industrial area along seashore for less than 19 years. The microscopic fracture surfaces by SEM are shown in Figs.3.21 and 3.22 respectively. The intergranular fracture surfaces are observed in these figures. The corrosive pits in intergranular fracture surface will be made by exposing in the corrosive atmosphere at industrial area after broken by delayed fracture. In the case of delayed fracture of bolt, the crack is mostly generated from incomplete thread and also generated from underhead fillet. The fracture from underhead fillet can be explained by the drop of water gathered in this area in the case of the bolt head settled downward or by the stress concentration due to the contact of washer to underhead fillet.

Fig.3.21 Observation results by SEM delayed fracture(6)
