# Failures of Fastening Screws and Their Preventive Methods

by Shin-ichi Nishida, Emeritus Prof. of Saga University

## Environmental failure of bolts, 4th report (the last half)

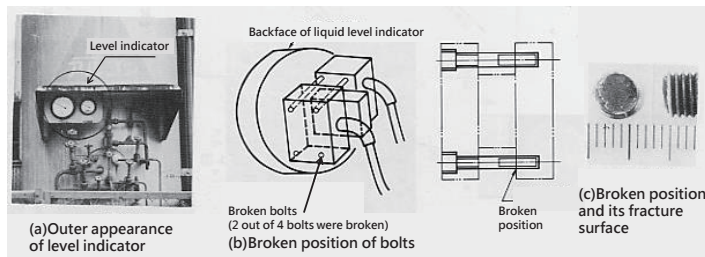
Excessive leakage of Ar gas was detected from the rear side of the level gauge for an Ar-gas holder. On inspection, it was found that the fastening bolts of the level gauge were broken. Since many gauges of the same type were in use, the broken bolt was closely investigated to prevent recurrence of the same trouble. The gauge had been in service for 6 years and 10 months. Bolt details are SUS630 (H900), 1/4-20UNC, unified thread, outside diameter:  $\phi 6.35$  mm, root diameter:  $\phi 4.976$  mm, pitch: 1.27 mm, thread length: 25.4 mm, overall underhead length: 63.5 mm, tightening torque: 2 kgf·m. An axial tension of 317 kgf is produced when the gas pressure is 70 kgf/cm<sup>2</sup> (see Fig.4.1).

Fig. 4.1 Outer appearance of equipment and broken position

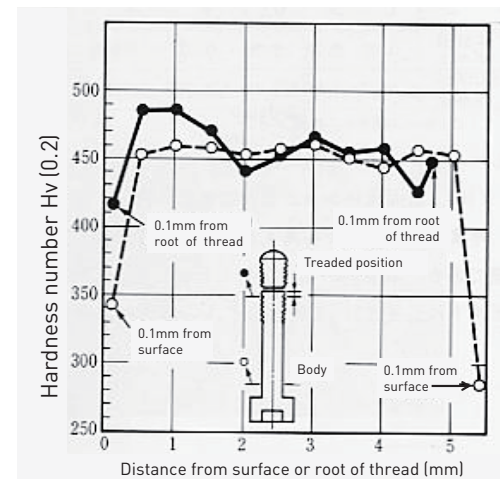
Fig.4.2 Hardness distribution of body threaded portion

The hardness distribution is shown in Fig.4.2. Though a noticeable difference in hardness distribution is observed between the vicinity of the broken point and the body, the hardness of the whole bolt is very high.

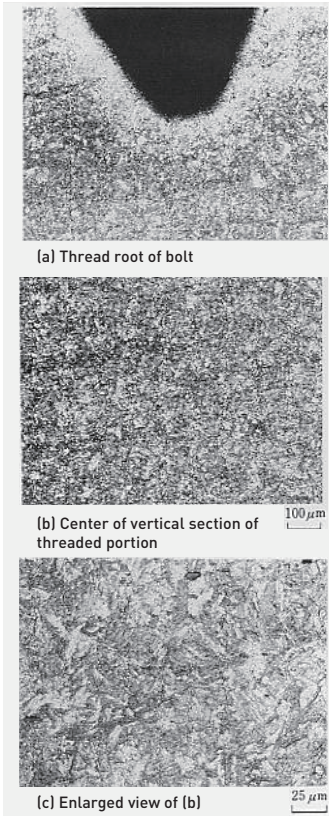
The optical micrograph is shown in Fig.4.3. The microscopic structure shows a tempered martensitic structure. Therefore, the tempering temperature is considerably low.

Fig. 4.3 Microstructure of broken bolt

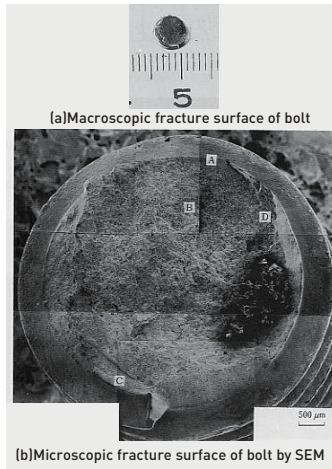
It will be noted from Figs.4.4 and 4.5 that a large proportion of the fracture surfaces is the intergranular fracture surface. The final fracture is a ductile fracture. The existence of Cl and S was detected when part of the fracture surface was analyzed (see Fig.4.6). Corrosion pits were locally observed at the thread root and body of the bolt (see Fig.4.7).

Fig.4.4 Observation result of fracture surface

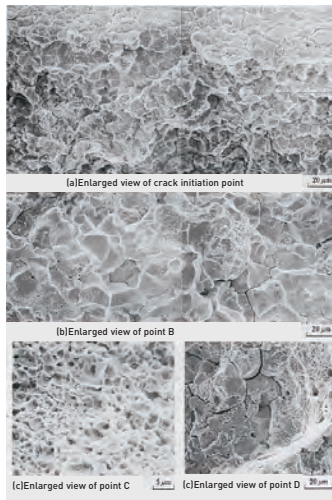
axial tension for tightening this bolt is 105 kgf/mm<sup>2</sup>. It may be said that this tension is quite large. In cases where the tensile strength of a bolt is very high (about 150~160kgf/mm<sup>2</sup>) and the axial tension for tightening is large as described above, the bolt becomes sensitive to the influence of the environment and is apt to fracture in a brittle fashion (see Fig.4.5).

Fig.4.5 Observation results of fracture surface by SEM (ref. Fig.4.4)

Summarizing the results of the investigation described above, it is judged that the so-called stress corrosion cracking resulted from pitting caused in the high-tension bolt which was tightening under a large tightening axial force. To prevent this cracking, it will be effective to decrease the strength of the bolt by changing the heat-treating condition from H900 to H1075 and to decrease the bolt-tightening torque from 2 kgf-m to 1 kgf-m. In addition, Fig.4.8 shows the effect of yield strength on KISCC in H<sub>2</sub>S and will introduce the more adequate material against stress corrosion crack.

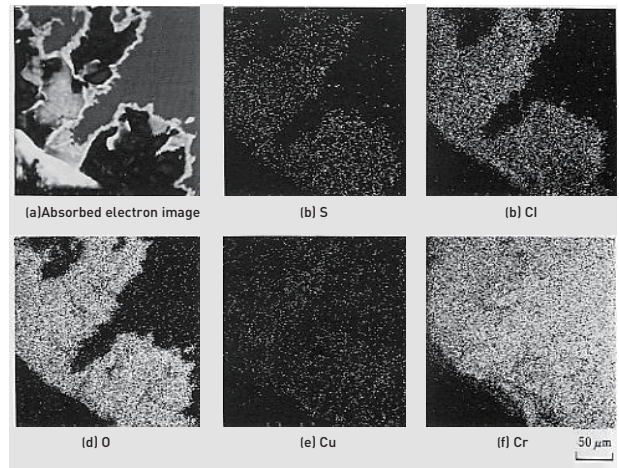
Fig.4.6 Chemical analysis of fracture surface

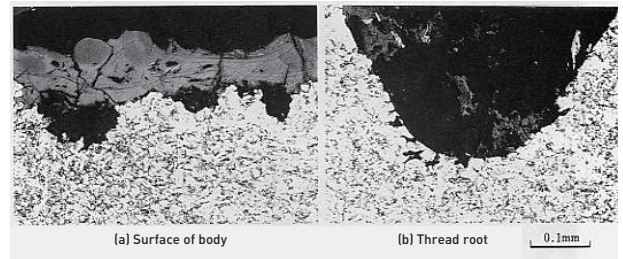
Fig.4.7 Microstructure in vertical section of bolt

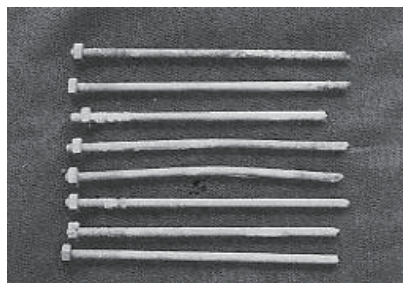
Figure 4.10 shows the outer appearance of broken bolts. These bolts were broken from the jointed portion to the steel plate and the surface of those was covered with brown rust. In addition, the rust color is printed into some parts of the inner insulating materials (black area of the silica board), where contacts to the steel plate. From the above fact, wet condition will be kept among steel plate, silica board and bolt.

Fig.4.10 Outer appearance of broken bolts (φ6mm)

The countermeasure of the above failures is to prevent the invasion of  $Cl^{-1}$  into the above environment. That is, the careful maintenance and management will be requested

to prevent the leakage of seawater from skid pipe and to use the insulating materials free from  $Cl^{-1}$  and to use anti-SCC steels. The SCC resistance of stainless steels from intergranular fracture shows the following order; SUS304 < SUS316 < SUS310S < SUS430, 15/18Cr-12/15Ni-3/5Si austenitic stainless steel. The life of heating furnace is about 10 years and SUS310S will be adequate in this case by considering into its weldability (see Fig. 4.20).

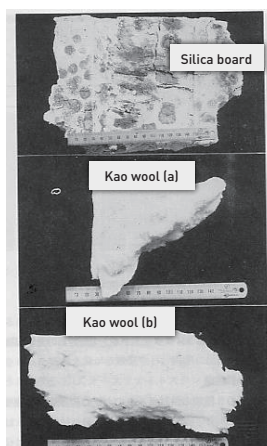
Fig.4.11 Outer appearance of thermal insulating materials near broken bolts

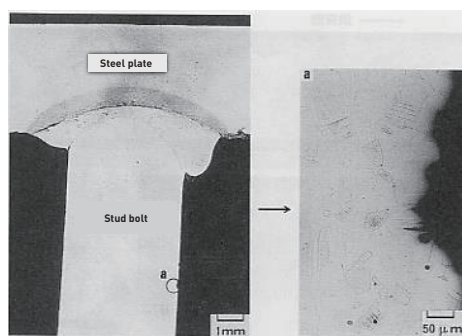
Figures 4.12 and 4.13 show microscopic structure of the vertical section of stud bolt, respectively. The plural micro-cracks are initiated from outer surface (bottom of pit) and propagate at a right angle to the axis of bolt along mainly grain boundaries like zigzag. The boundary carbide is precipitated in the overall length of the bolt. Therefore, it is considered that this bolt was heated in the high temperature of precipitation of boundary carbide between 400~800°C. However, as the above condition will be made after the fall of the insulating materials, the temperature of bolt in crack initiation, will be less than 400°C.

Fig.4.13 Vertical section of SUS304 stud bolt and its enlarged view of corrosion pits

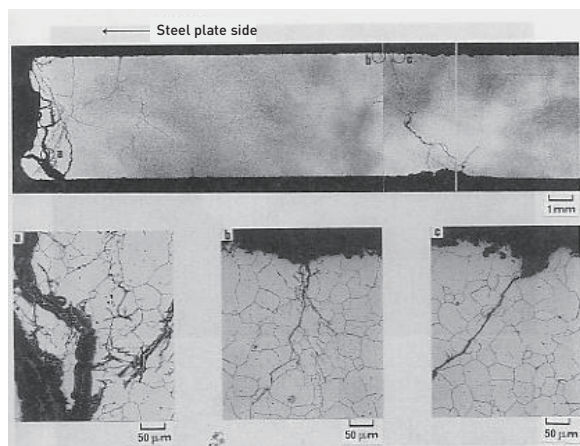
Figure 4.14 shows the optical microstructure of the vertical section of stud bolt and SCC cracks initiation. In addition, Fig. 4.15 shows the vertical section of broken stud bolt and its enlarged view of cracks. As can be seen from these figures,

the cracks initiate from here and there in the case of SCC and propagate mainly along grain boundaries in association with trans-granular fracture. In addition, the cracks propagate into all of direction like a streak of lighting and show remarkable branching.

Fig.4.14 Vertical section of stud bolt and its microstructure of SCC

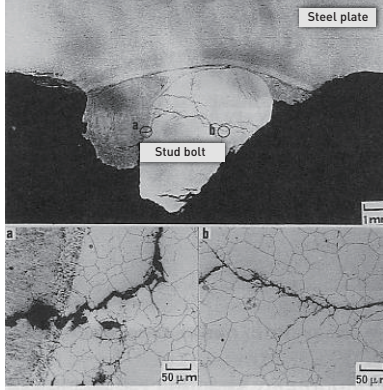
Fig.4.15 Vertical section of broken stud bolt and its enlarged view of cracks

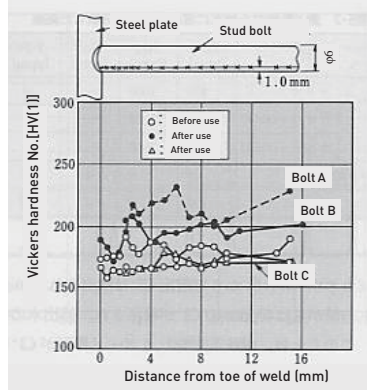
Figure 4.16 shows hardness distribution of vertical section of stud bolts. The hardness of broken bolts (bolt A, B) and unused bolt are between Hv=170~230 and Hv=160~190, respectively. The former is higher than the latter by  $\Delta Hv=10\sim40$  and this value will be caused due to work hardening during operation. At first, the axial tensile stress, which supports the insulating materials, is 0.69MPa, whose stress cannot affect work hardening to the stud bolt. There is high possibility about the following stress: vibration during operation of heating furnace  $\rightarrow$  shake of the insulating materials and bolts laterally  $\rightarrow$  bending stress at the jointed portion of bolt. In addition, the cold working ratio will be estimated to be 1~4% due to the increase of  $\Delta Hv=10\sim40$  (ref. Fig.4.17). The hardness of bolt C ( $\Delta$ ) shows the same value as unused bolt and this phenomenon will be caused that the stud bolt becomes heated until high temperature of precipitation of intergranular carbide

Fig.4.16 Hardness distribution of vertical section of stud bolts

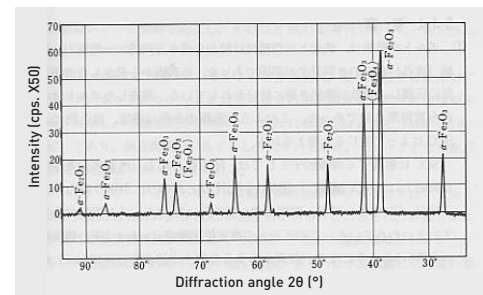
Figures 4.18 and 4.19 show X-ray diffraction pattern of the rust on the surface of stud bolt, the steel plate and chemical analysis, respectively. In addition, Fig. 4.20 shows relative SCC resistance of stainless steels and this relative resistance shows higher value in the upward and right hand side direction.

Fig.4.18 X-ray diffraction pattern of rust on stud bolt surface and chemical analysis

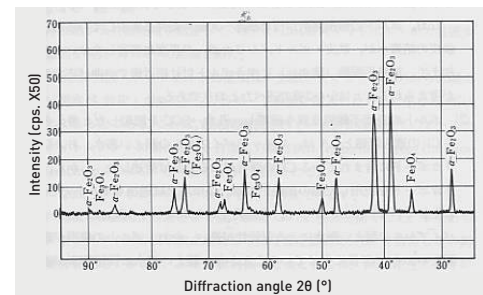
Fig.4.19 X-ray diffraction pattern of rust on steel plate surface and chemical analysis
