# Failures of Screws and Their Preventive Methods

Emeritus Prof. of Saga University,  
Shin-ichi Nishida

## —Environmental failure of bolts, (the first half), 3rd report—

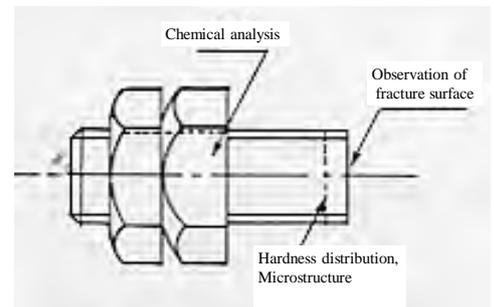
Fig.3.3 Sampling procedure

The sampling procedure is shown in Fig.3.3.

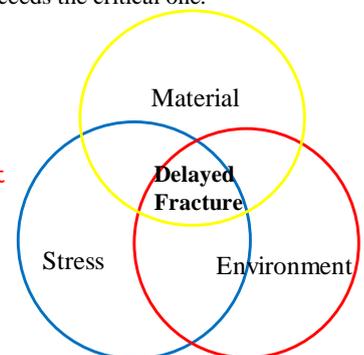
**Fig. 3.15 Initiation condition of delayed fracture**

Figure 3.15 shows initiation condition of delayed fracture. As is shown in this figure, delayed fracture initiates when material, stress and environment satisfy a certain condition. As several models have been already presented, most general one is illustrated in Fig. 3.16.

**Delayed fracture initiates when stress, material and environment satisfy specific condition.**
