# Failures of Fastening Screws and Their Preventive Methods

by Shin-ichi Nishida, Emeritus Prof. of Saga University

## Environmental failure of bolts, 4th report (the last half)

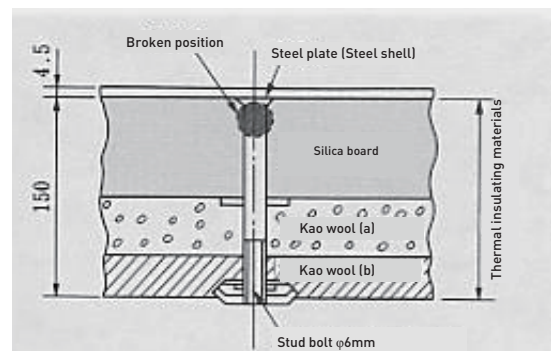
Fig.4.9 Schematic illustration of fastened stud bolt

The heating furnace for steel blooms is composed of a pre-heating zone, heating zone and soaking zone from the charging side with atmospheric temperature between 600 and 1300°C. The stud bolts are broken in the pre-heating zone (600~800°C), i.e. in the relatively low temperature. Figure 4.9 shows the schematic illustration of stud bolt fastened. As shown in this figure, the stud bolt is welded by resistance welding with steel plate (SS400, thickness in 4.5mm in

the ceiling with 2m in height from the furnace bottom oriented with skid pipes. The insulating materials are made of three layers with silica board, Kao wool (a) and Kao wool (b) from the steel plate side. The several hundreds of SUS304 stud bolts are broken and the insulating materials of 20m<sup>2</sup> (in area) fell down after three years since operation. In addition, the steel plate was over 60°C in temperature and the theoretical dew point of fuel gas is 58°C. When the temperature of furnace decreases, there is possibility that the dewing happens among the steel plate, the bolts and the insulating materials.

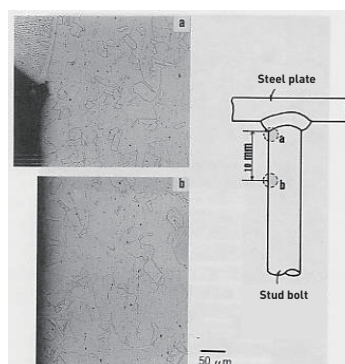
Fig.4.12 Optical microstructure of vertical section of an unused stud bolt

Figures 4.12 and 4.13 show microscopic structure of the vertical section of stud bolt, respectively. The plural micro-cracks are initiated from outer surface (bottom of pit) and propagate at a right angle to the axis of bolt along mainly grain boundaries like zigzag. The boundary carbide is precipitated in the overall length of the bolt. Therefore, it is considered that this bolt was heated in the high temperature of precipitation of boundary carbide between 400~800°C. However, as the above condition will be made after the fall of the insulating materials, the temperature of bolt in crack initiation, will be less than 400°C.

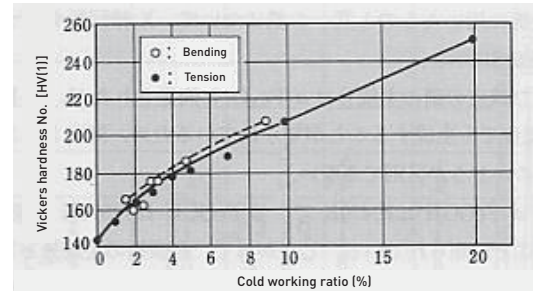
Fig.4.17 Relation between cold working ratio and Vickers hardness No. of SUS304

Figure 4.16 shows hardness distribution of vertical section of stud bolts. The hardness of broken bolts (bolt A, B) and unused bolt are between Hv=170~230 and Hv=160~190, respectively. The former is higher than the latter by  $\Delta Hv=10\sim40$  and this value will be caused due to work hardening during operation. At first, the axial tensile stress, which supports the insulating materials, is 0.69MPa, whose stress cannot affect work hardening to the stud bolt. There is high possibility about the following stress: vibration during operation of heating furnace  $\rightarrow$  shake of the insulating materials and bolts laterally  $\rightarrow$  bending stress at the jointed portion of bolt. In addition, the cold working ratio will be estimated to be 1~4% due to the increase of  $\Delta Hv=10\sim40$  (ref. Fig.4.17). The hardness of bolt C ( $\Delta$ ) shows the same value as unused bolt and this phenomenon will be caused that the stud bolt becomes heated until high temperature of precipitation of intergranular carbide

and applied by stress relief annealing (SR), then work hardening due to applied stress will disappear.

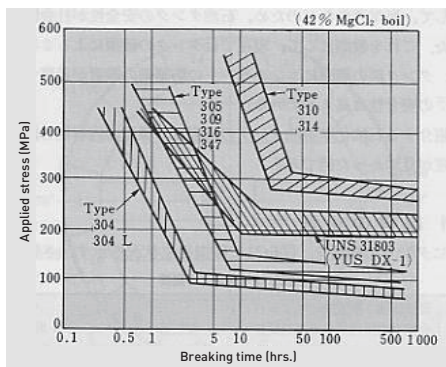
Fig.4.20 Relative SCC resistance of stainless steels

Figures 4.18 and 4.19 show X-ray diffraction pattern of the rust on the surface of stud bolt, the steel plate and chemical analysis, respectively. In addition, Fig. 4.20 shows relative SCC resistance of stainless steels and this relative resistance shows higher value in the upward and right hand side direction.

to prevent the leakage of seawater from skid pipe and to use the insulating materials free from  $Cl^{-1}$  and to use anti-SCC steels. The SCC resistance of stainless steels from intergranular fracture shows the following order; SUS304 < SUS316 < SUS310S < SUS430, 15/18Cr-12/15Ni-3/5Si austenitic stainless steel. The life of heating furnace is about 10 years and SUS310S will be adequate in this case by considering into its weldability (see Fig. 4.20).
